Report No. 0162-01TN-62-18

HIGH- AND LOW-TEMPERATURE TESTS
OF THE AEROJET UTILITY VAN

AFBSD Technical Note BSD-TDR-62-331

AEROJET-GENERAL CORPORATION

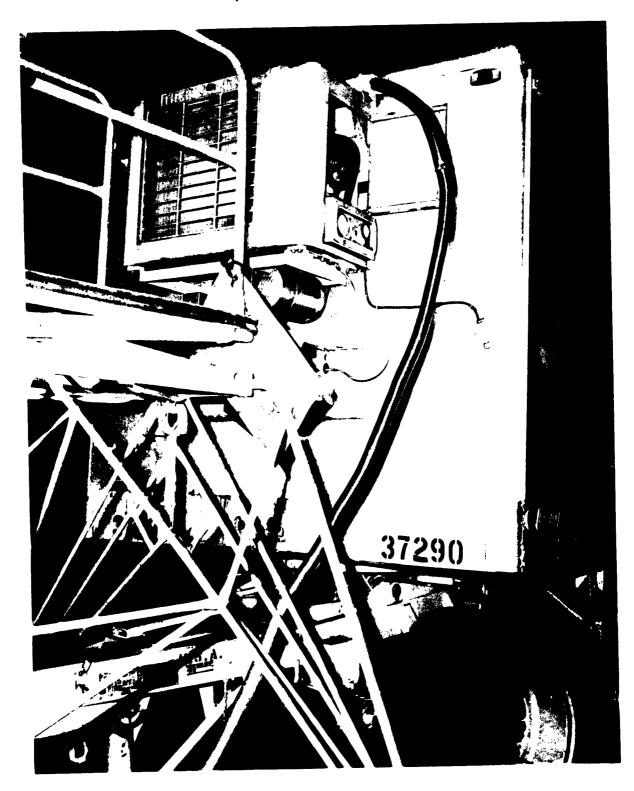
The interior temperature of the van was regulated by a Thermo-King temperature-control unit, Model K30A. The unit, installed on the exterior forward wall of the van (Figure 2), provided heat from three heater strips powered by

220 vac. Cooling was provided by the refrigeration section of the unit. In accordance with standard summer practice, the louvered top cover and shutters of the unit had been removed.

Thermo-King Temperature-Control Unit Installed on Aerojet Utility Van (View of Right-Forward Corner of Van)

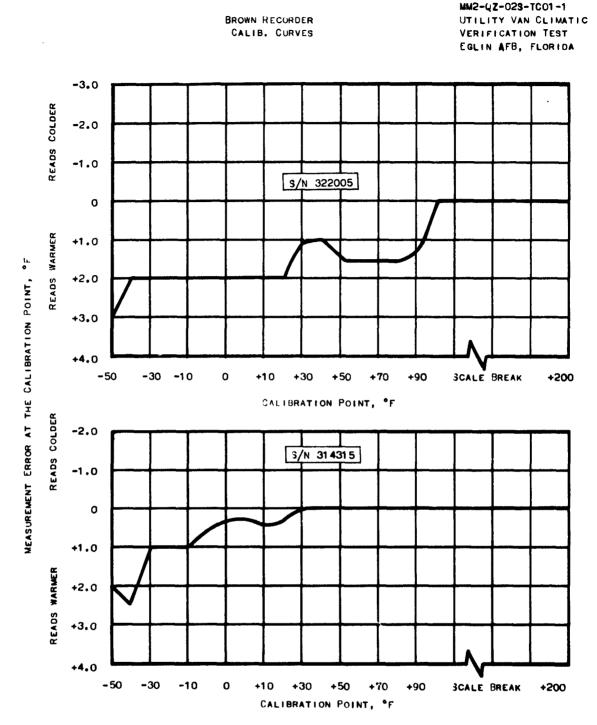
Figure 5

CALIBRATION INPUT VOLTAGE AT EACH POINT SUPPLIED BY LEEDS AND NORTHRUP K-2 POTENTIOMETER.

CALIBRATIONS OBTAINED ON 8 AUGUST 1962.

Calibration Plot of Print-Out Recorders

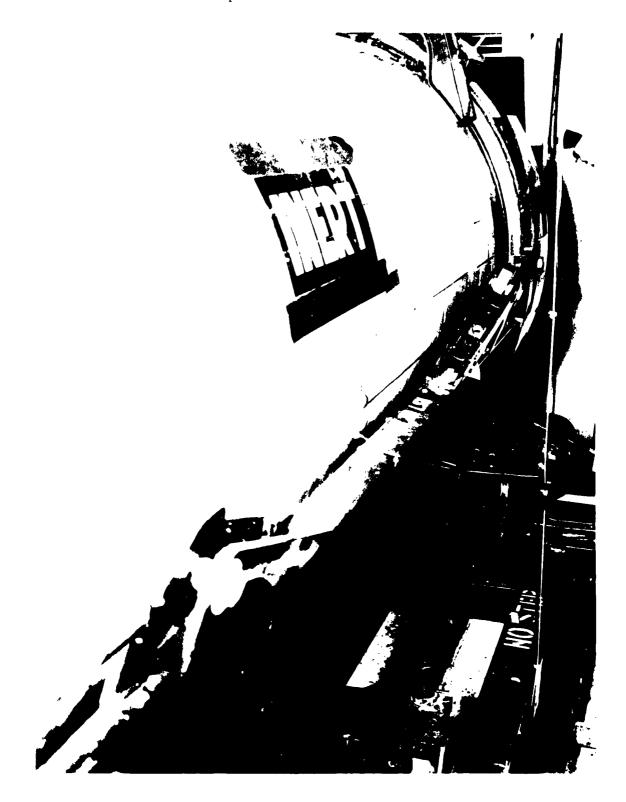
Figure 9

Instrumentation at Right Side of Motor

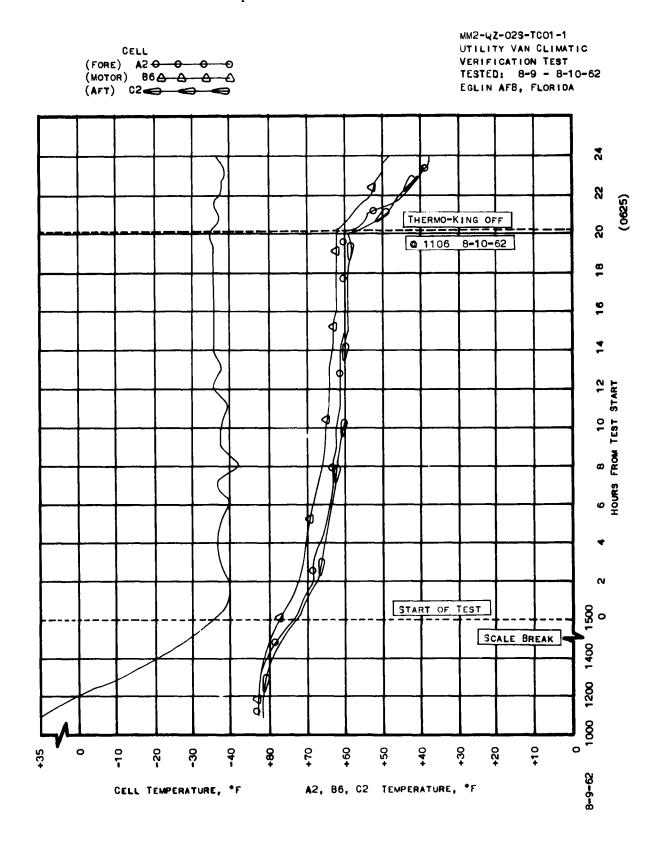
Figure 11

Low-Temperature Test Data (Plot of Thermocouples A2, B6, and C2)

At 1030 hours on 9 August, temperature conditioning of the cell was started. The required low temperature of 35 ±5°F for the interior of the cell was recorded at 1500 hours and temperature stabilization of the motor began. The test proceeded without incident except for a period of 1.5 hr during which the operation of the Thermo-King unit was intermittent. A defective circuit in post-to-fuse connection was discovered, and corrective action was taken. At 0700 hours on 10 August, 16 hr after the test began, the surface temperature of the motor stabilized at +60°F. At 1100 hours, the Thermo-King unit was switched off. The average van-interior and motor-surface temperatures at this time were 59 and 60°F, respectively. After 4 hr without heating, the temperature recordings of the van interior ranged from 32 to 38°F, and the motor-surface temperature ranged from 45 to 49°F. An attempt to restart the Thermo-King unit on conclusion of the test was unsuccessful. At 1505 hours, the cell temperature was returned to +80°F and the van doors were opened. Figures 11 and 12 show the recorded low-temperature data in graph form.

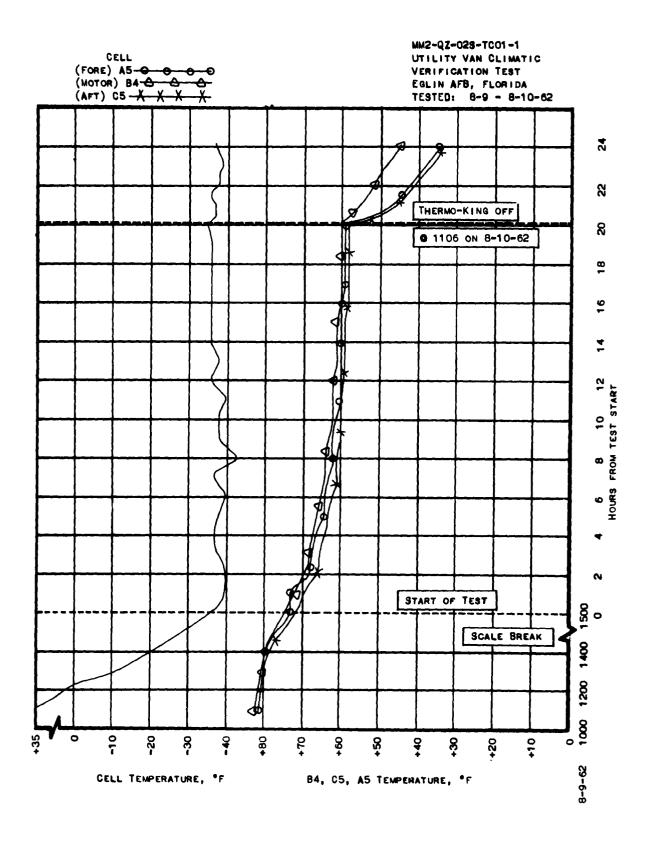
Figure 12

Low-Temperature Test Data (Plot of Thermocouples A5, B4, and C5)
